MCM devices are used for condition monitoring at Renault

## **CASE STUDIES AT RENAULT**

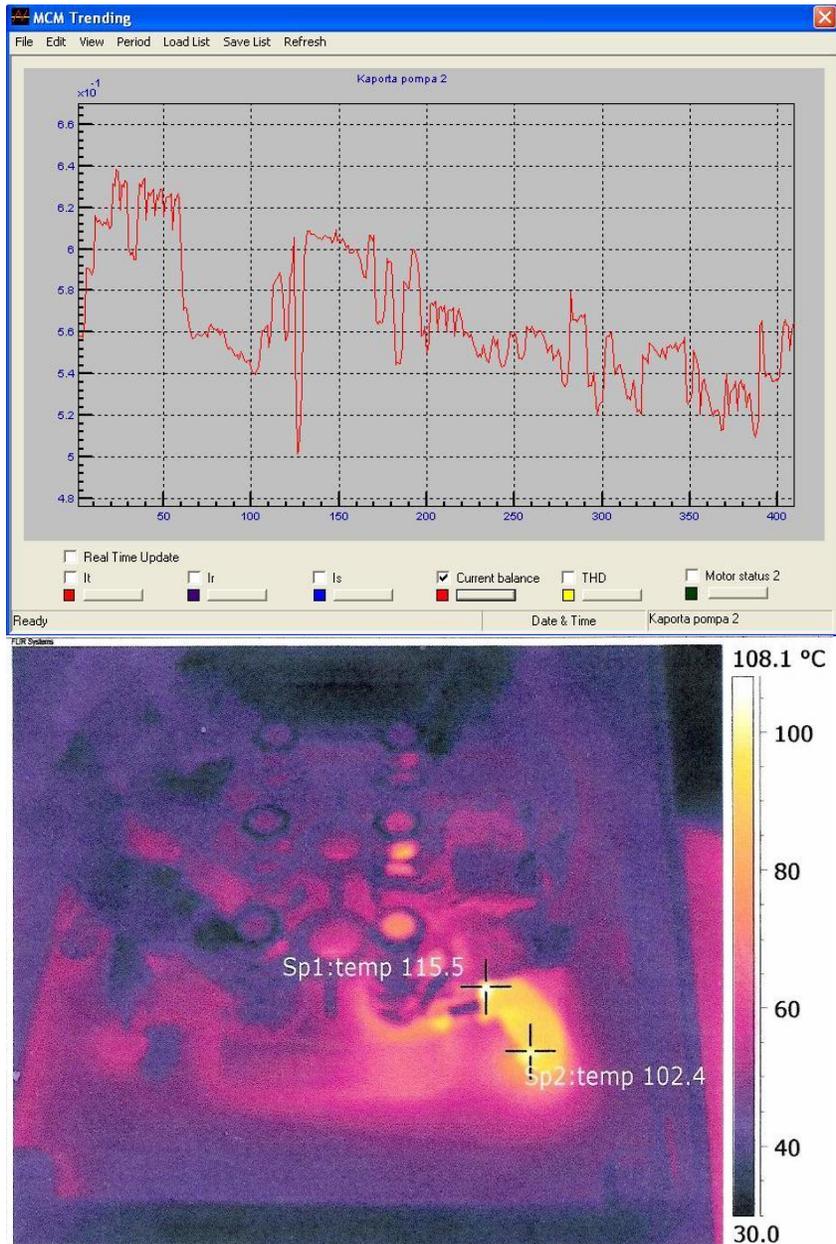
One of the MCM used with a pump at Renault gave warning. MCMSCADA, the diagnostic graphical user interface of MCM, indicated that the developing fault is an internal electrical fault. An examination of current imbalance showed that its value was changing over time. A change in current balance together with an internal electrical problem indicated to the isolation in stator windings. The team took a thermal camera picture of the motor and verified the detection and diagnostics of MCM. The maintenance crew replaced the motor with a spare one to prevent unexpected down time.

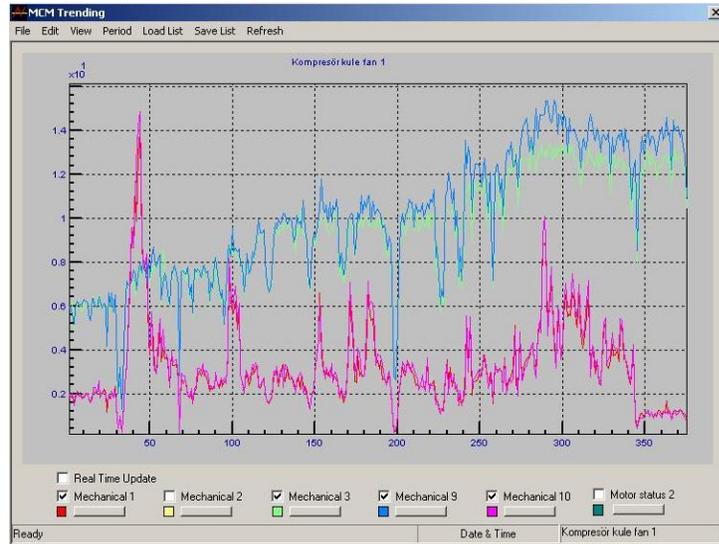
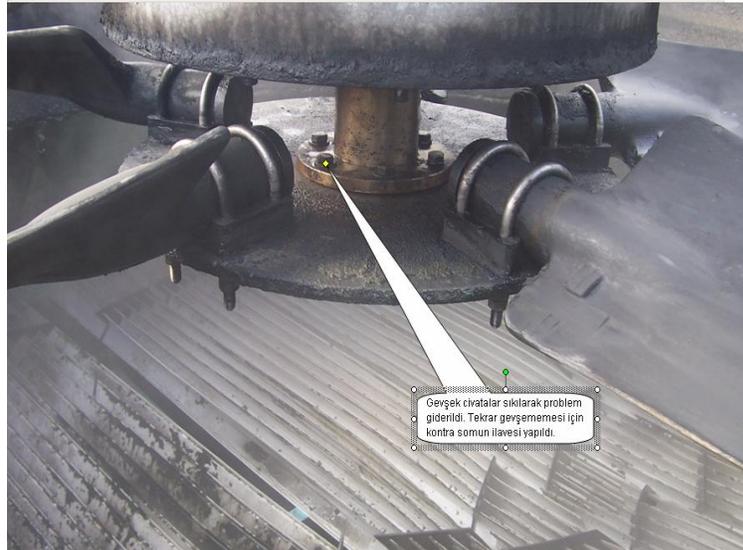
The second case was a tower fan monitored by one of the MCM. In this case MCM started giving early warning of a developing fault. The parameters associated with loose foundation and imbalance showed a continuous and sustained increase. Two months after the early warning and on a regular maintenance stop, the maintenance team examined the fan. They observed visually that the bolt tightening MCM to the foundation was loose as shown in the picture.. They fixed the bolt to remedy the problem.
